Aston Workshop

RESTORATION LOG

DB4 Series IV Chassis no. DB4/938/R
Engine no. 378/933

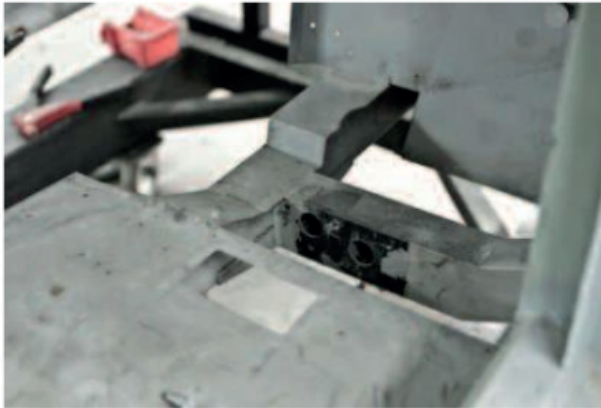
So as part of this assessment, the shell was removed in two halves, the rear structure that runs from the B Post backwards and the front section that runs forward from the A Post. The front shell was separated at the base of the windscreen pillar and the rear section halfway up the rear window in line with the rear window and quarter-light. The front skin was unclenched from around the frame that surrounds the bonnet aperture together with the base of the windscreen frame. At the rear, the boot aperture and rear window frame provide the principal anchorages and the skin was unclenched from that also.

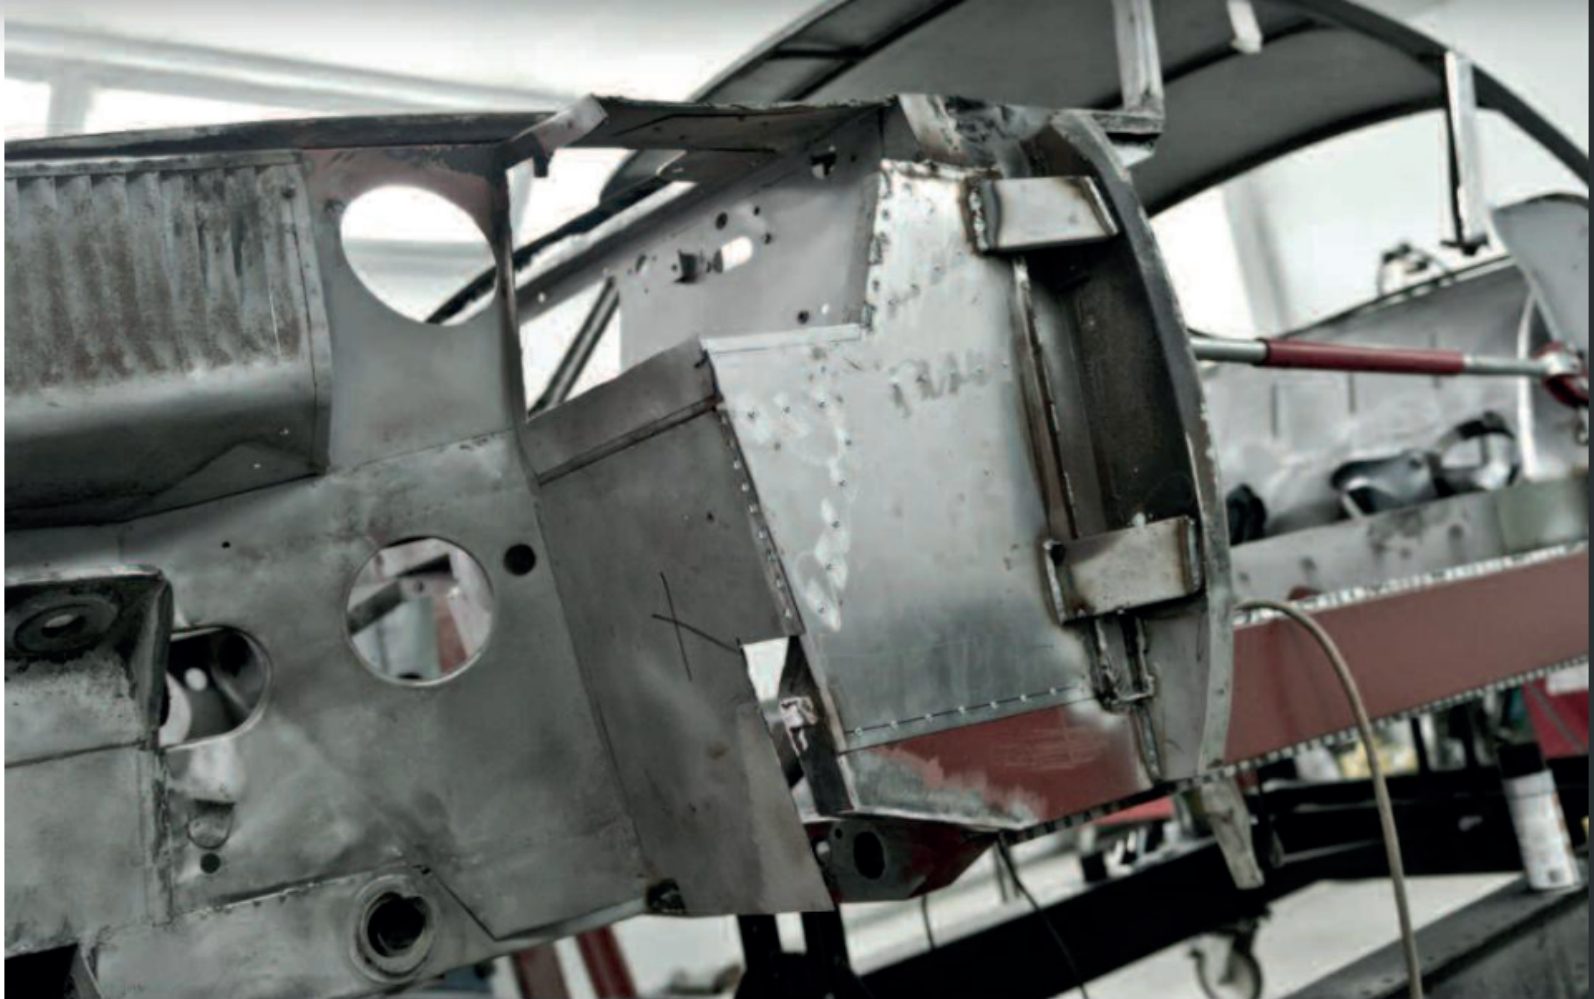
case, the outer forlorn state of the car was perhaps also an accurate indicator of its inner state, which was poor.

Not only were the sills showing an advanced state of decay but also the front outriggers, the rear chassis legs and a boot floor that showed more resemblance to lace than something solid. The rear suspension anchorages were equally unsound.

At the front, the base of the front foot wells, the front engine bulkhead and cross member was also heavily rust damaged, as were the under-bonnet side panels.

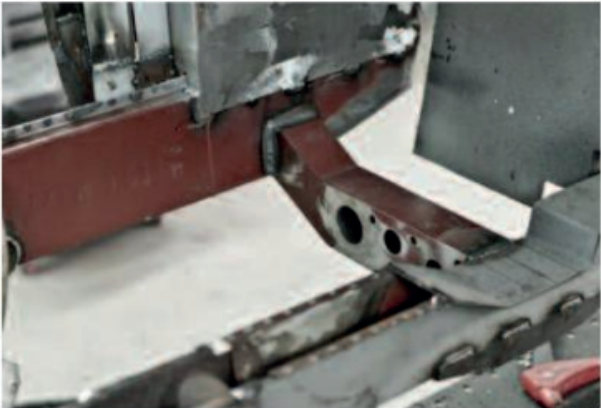
The doors were equally in a poor state and needed a total reconstruction. The doors on these cars suffer most from

the rotting out of the door bottoms. In turn this allows the door to twist and in advanced cases, the door hinge members start to break away and the door sags. There is no other alternative to a full reconstruction, but the frame can only be completed and the door skin clenched onto the doorframe once the front and rear body skins have been repaired and remounted.

The bonnet skin also showed signs of delamination, quite common with unrestored cars. At this stage a more accurate assessment of cost and time to completion was then possible.

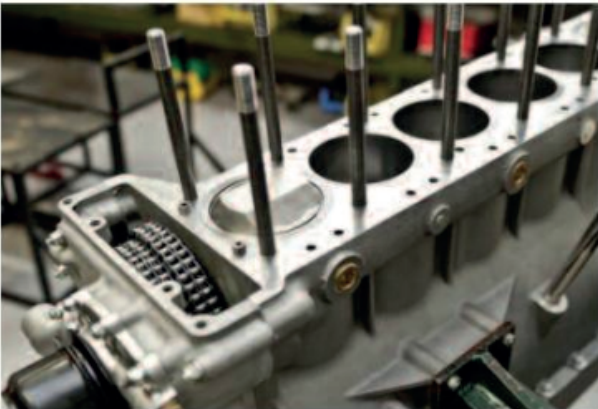
With the engine, gearbox and final drive now separated from the car, these were cleaned off and the engine was dismantled, with the first task being to remove all intake and exhaust manifolds, alternator, water pump and fan. This was followed by the separation of the bell housing and gearbox. The sump was then removed followed by the removal of the front timing case and chain, the oil pump and filter housing. The separation of the cylinder head followed, revealing for the first time the inner state of the cylinders and pistons.

As this car was to be totally restored, the next stage was to remove pistons and connecting rods, followed by the crankshaft, oil pump and strainer assembly and all of external fittings. The cylinder block was next inserted into an oven and heated, followed by the extraction of all cylinder liners. This revealed that the seatings for the liners though damaged, could be recovered. A check across all main bearing webs revealed no serious cracking. This meant that, subject to recovering the sound condition of the liner seatings, the block could be safely cleaned and reused.
